# RECONNAISSANCE REPORT OF DAMAGE TO HISTORIC MONUMENTS IN CAIRO, EGYPT FOLLOWING THE OCTOBER 12, 1992 DAHSHUR EARTHQUAKE

**Reconnaissance Report of Damage  
to Historic Monuments in Cairo, Egypt  
Following the October 12, 1992 Dahshur Earthquake**

Technical Report NCEER-93-0016

August 19, 1993

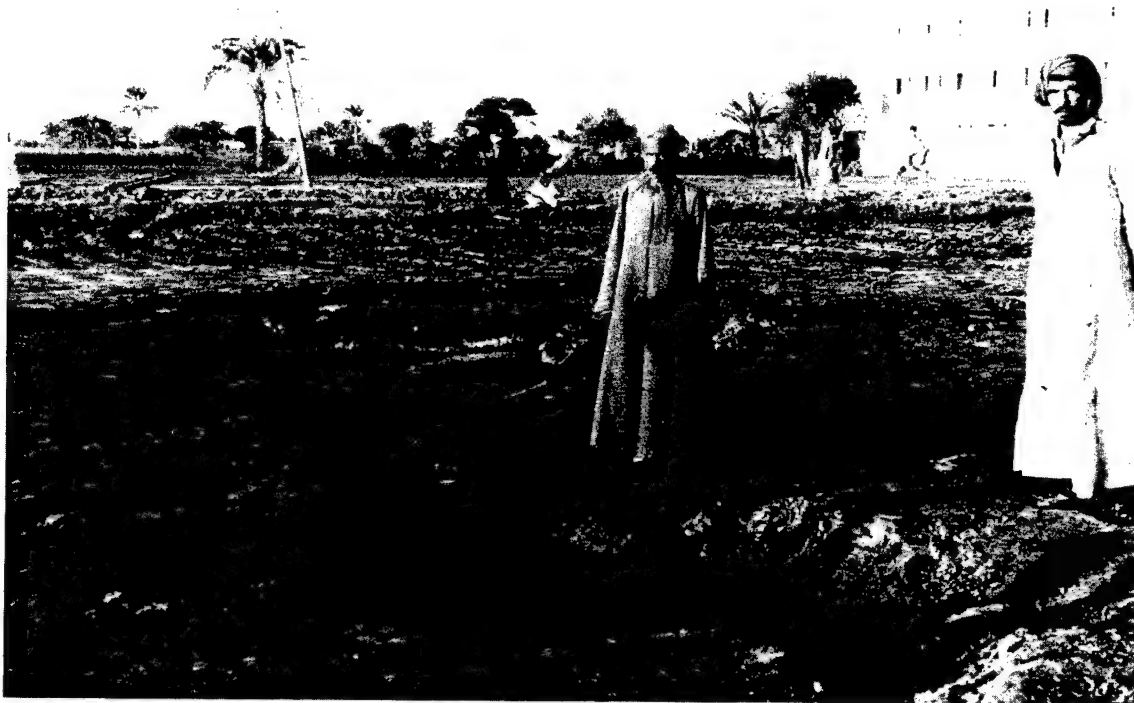
area defined by a seismic intensity of VIII (refer to figure 2-9). These manifestations included sand boils, earthquake-induced settlements of saturated soils, and lateral spreading and were documented shortly after the earthquake by Prof. Mohamed Amer at Cairo University (Elgamal, Amer, and Adalier 1993). An example of a remnant depression from a sand boil is shown in figure 2-10.

**FIGURE 2-10** Remnant craters from sand boils 20 km south of Cairo (courtesy of Ahmed Elgamal, Rensselaer Polytechnic Institute)

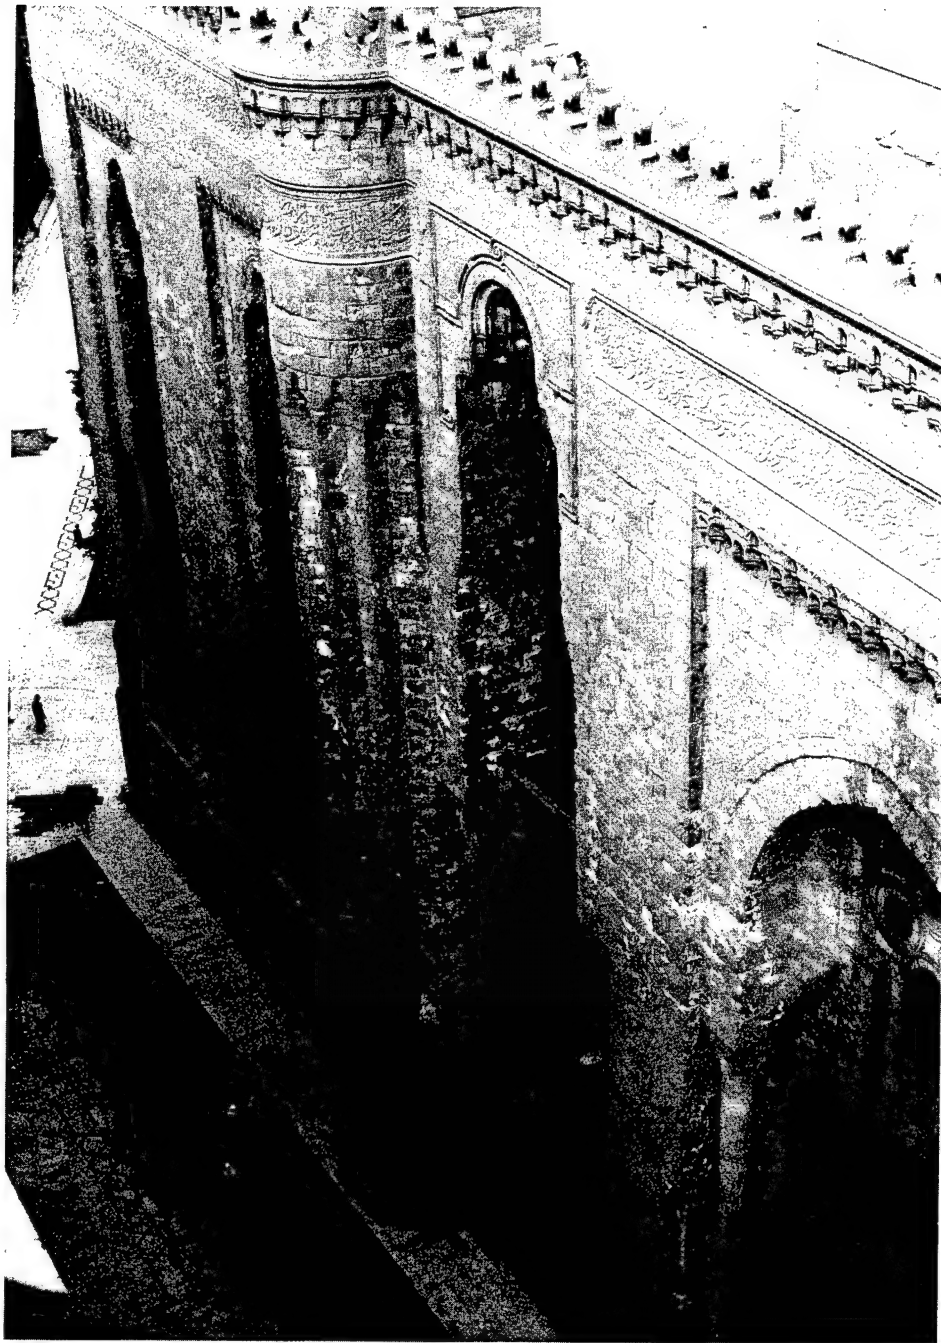
**FIGURE 4-1** Main portal of century-old al-Rifai Mosque looking down from the eastern minaret of the Sultān Hasan Mosque showing deterioration of masonry near arches

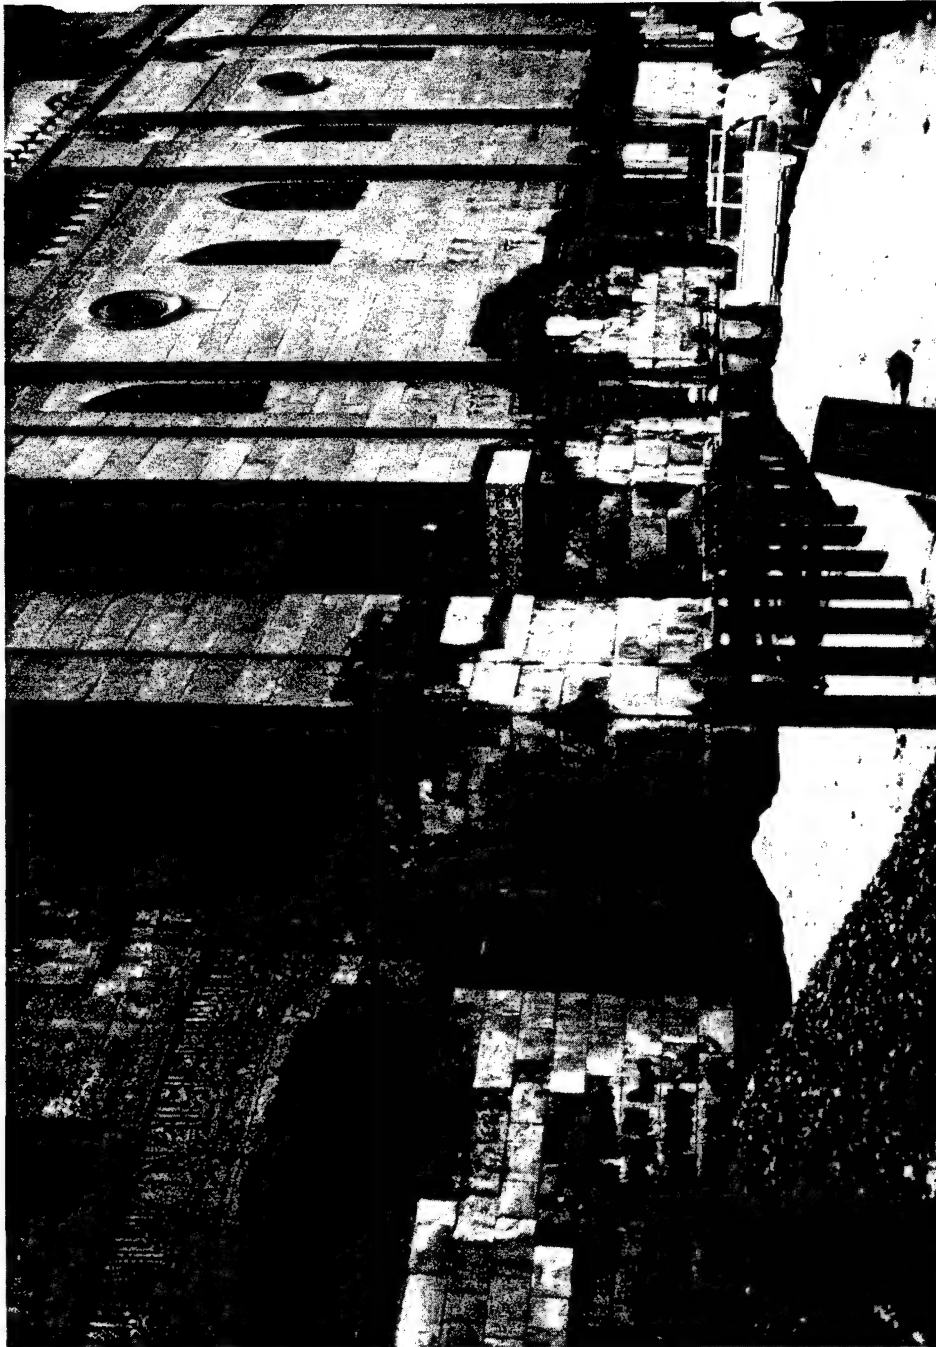
**FIGURE 4-4** Southwest exterior wall of Mosque of Sultān Barqūq looking north showing dampness in masonry and progressive deterioration with height

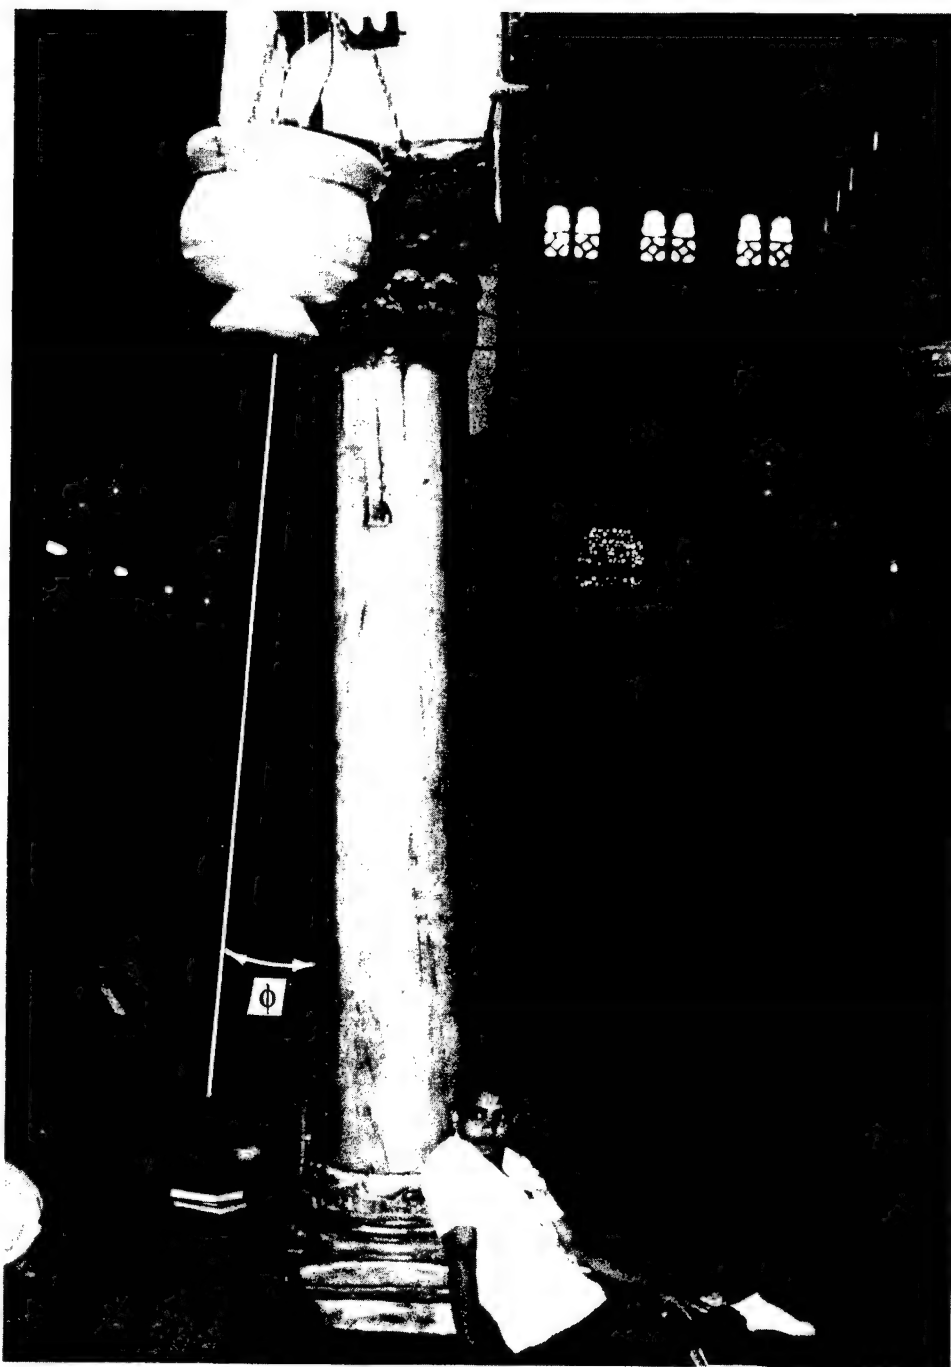
It is not known if thorough records of damage to historic monuments and reports of lessons learned exist anywhere in Egypt. Historic records generally state that mosques have been damaged and destroyed during previous earthquakes (refer to Table 3). Behrens-Abouseif (1985 and 1989) and SPARE (1981a) report that minarets at al-Hākim Bi-Amrillāh and al-Mansūr Qala'ūn mosques were damaged during the 1303 earthquake. The minarets of al-Hākim Bi-Amrillāh were rebuilt using the remaining base. The minaret of al-Mansūr Qala'ūn was repaired. Many of the monuments visited have cracks or other remnants from previous earthquakes. A tilted column remains at al-Azhar as shown in figure 4-6 (even though this monument was restored in 1980).

**FIGURE 4-6** Column of arcade at al-Azhar Mosque showing tilting effect from previous earthquake

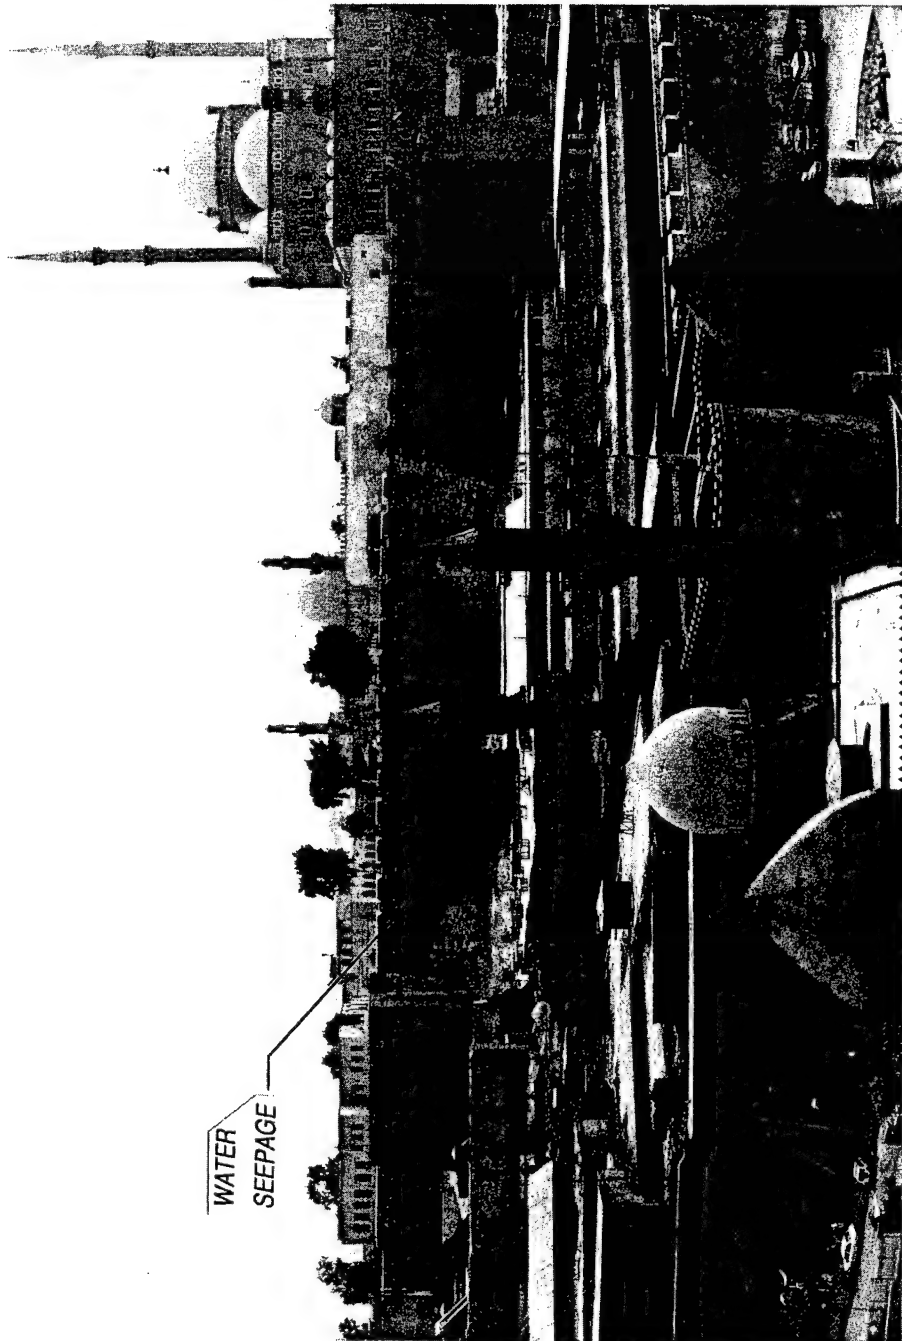
**FIGURE 4-9** Citadel looking east from Mosque of Sultān Hasan showing significant moisture seepage through upper wall

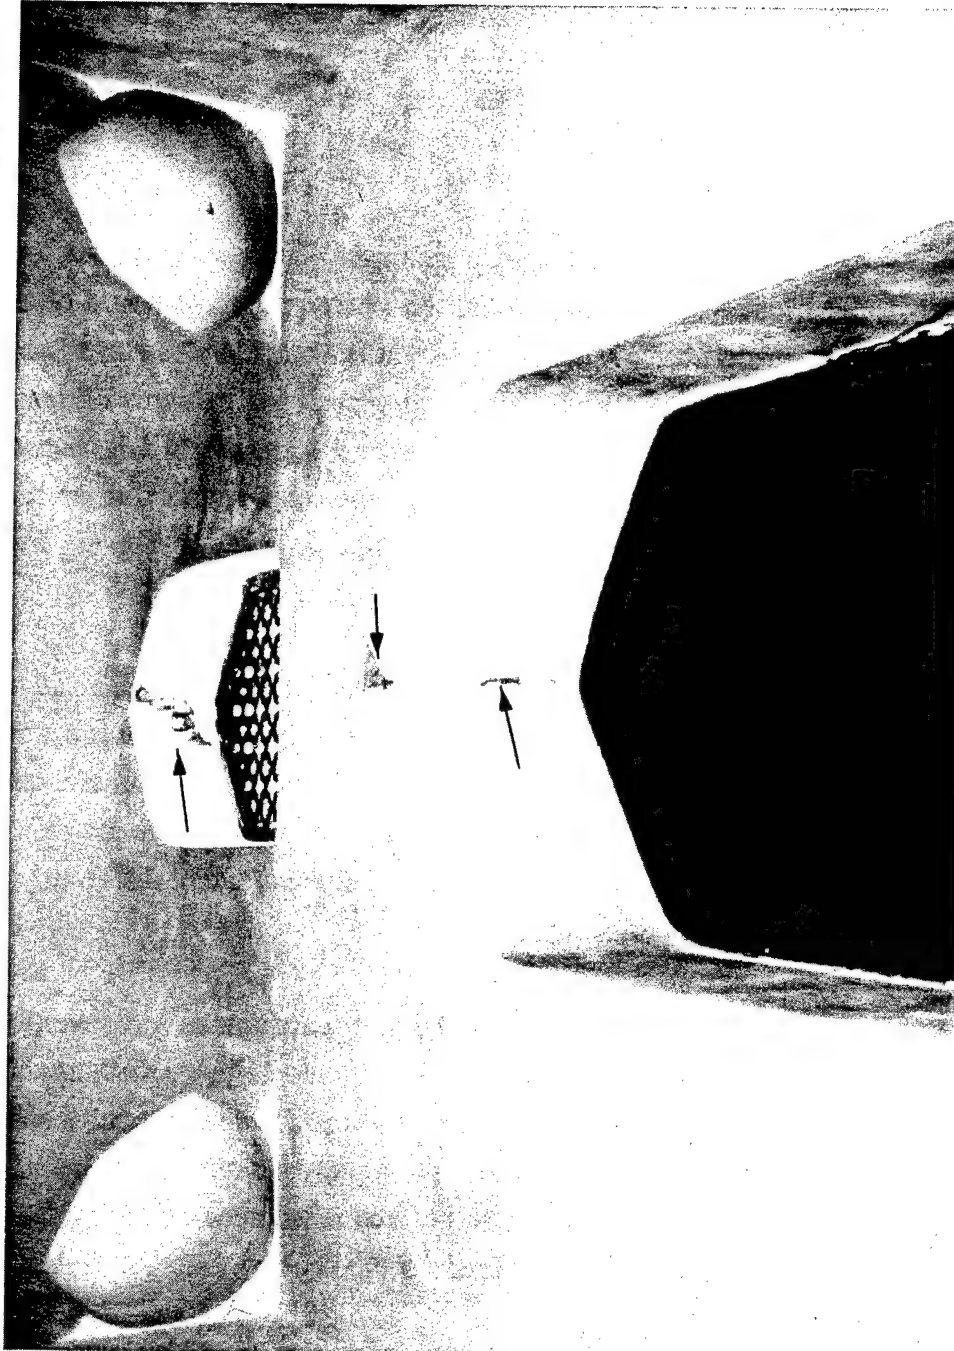
**FIGURE 4-10** Wall and small dome at Abu Sufein Church showing cracks and spalling at top of arches

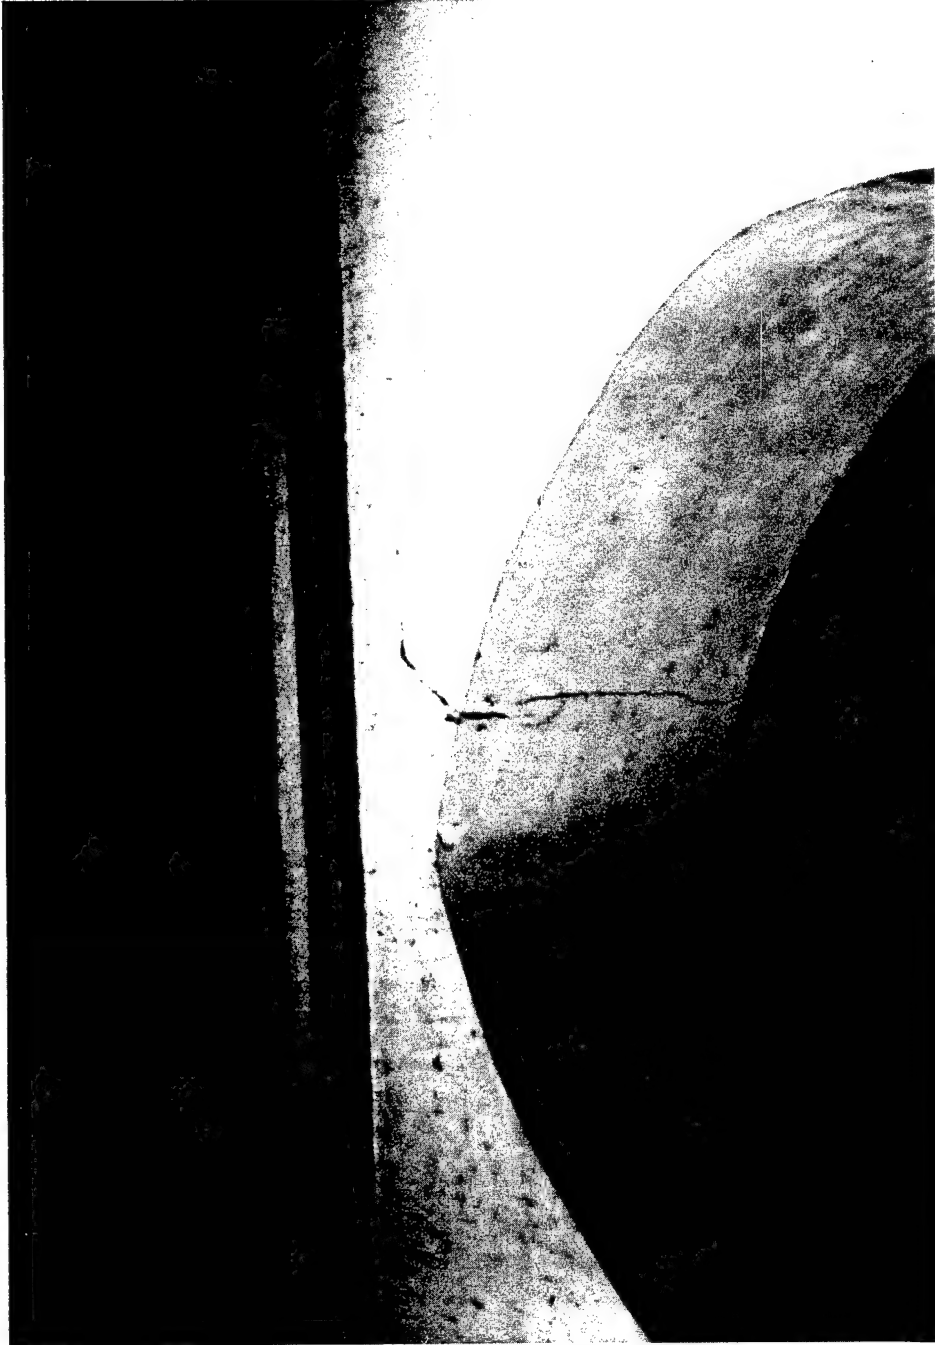
**FIGURE 4-11 Arch in arcade of al-Hākīm Bi-Amrillāh Mosque showing minor crack**

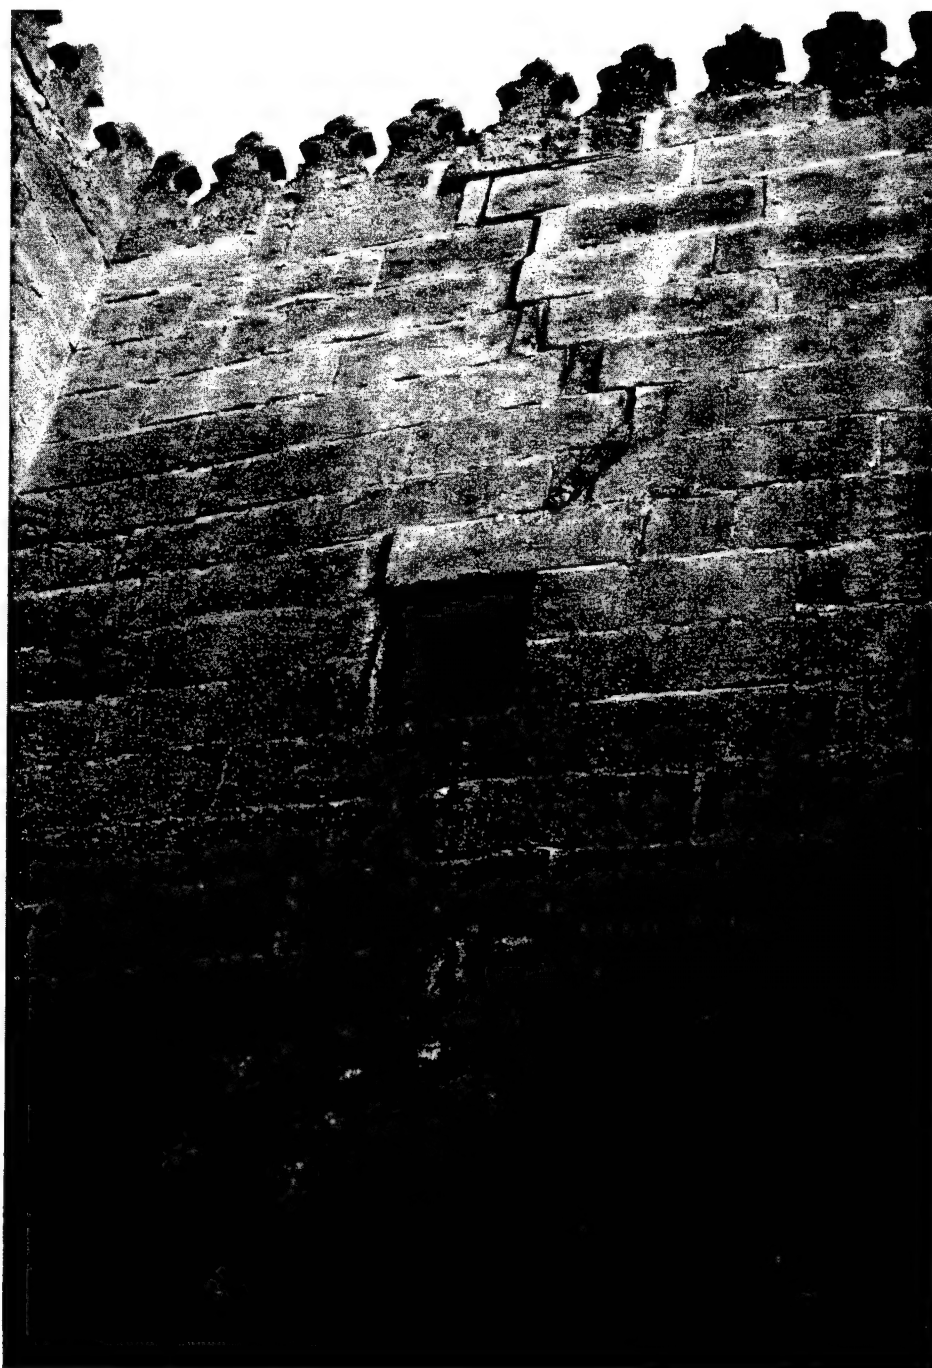
**FIGURE 4-12** Wall near back of Mosque of Sultān Barqūq  
showing extensive crack in southwestern wall

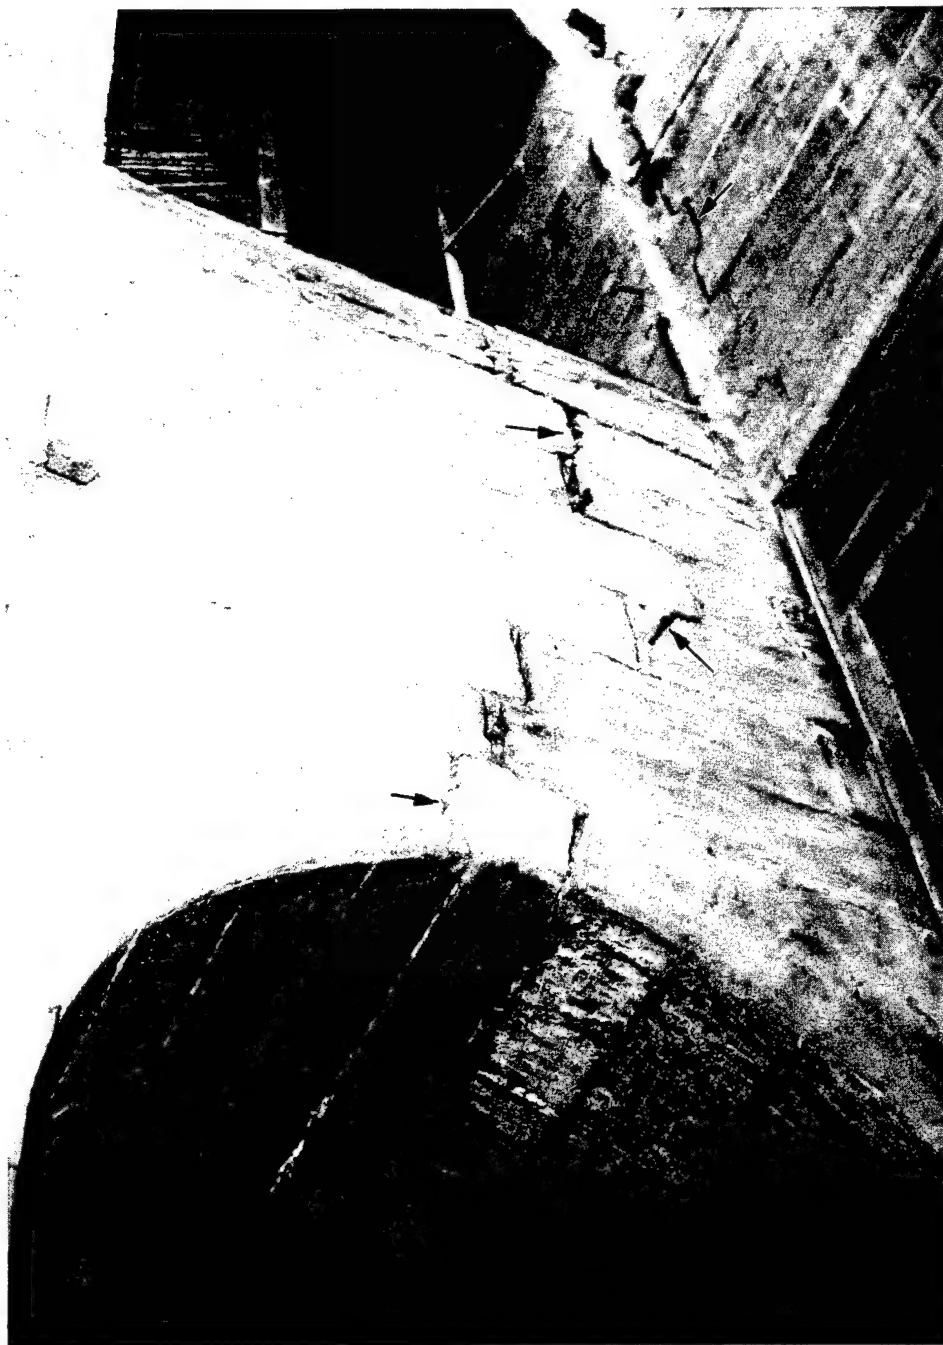
**FIGURE 4-13** Wall at southern corner of inner court of Mosque of Sultān Barqūq showing crack in southwestern wall extending down to arch

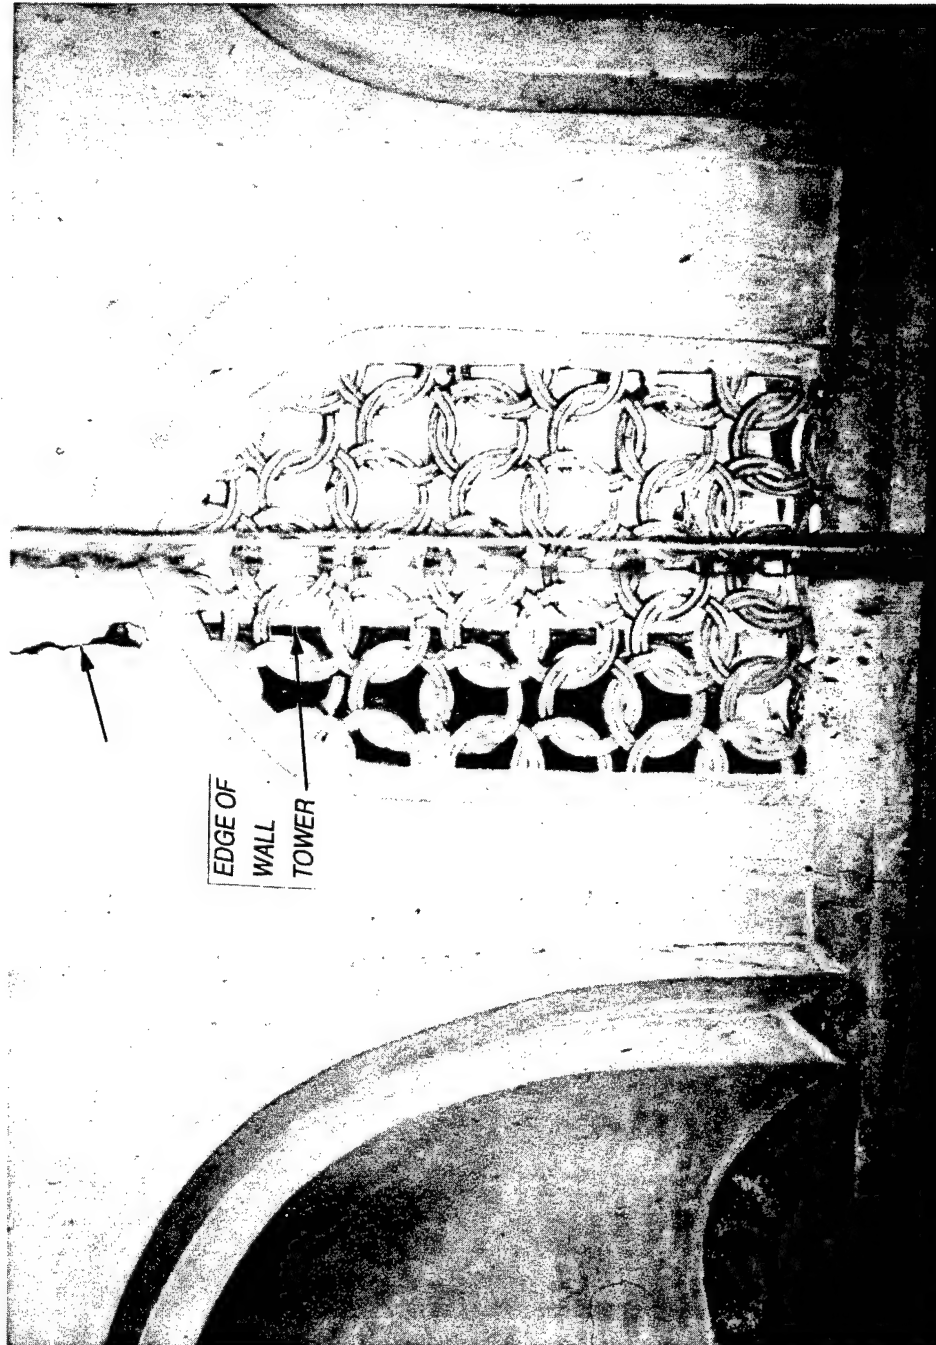
**FIGURE 4-14** Base of dome at eastern corner of al-Hakim Bi-Amrillah Mosque showing crack extending up from window corresponding to wall tower

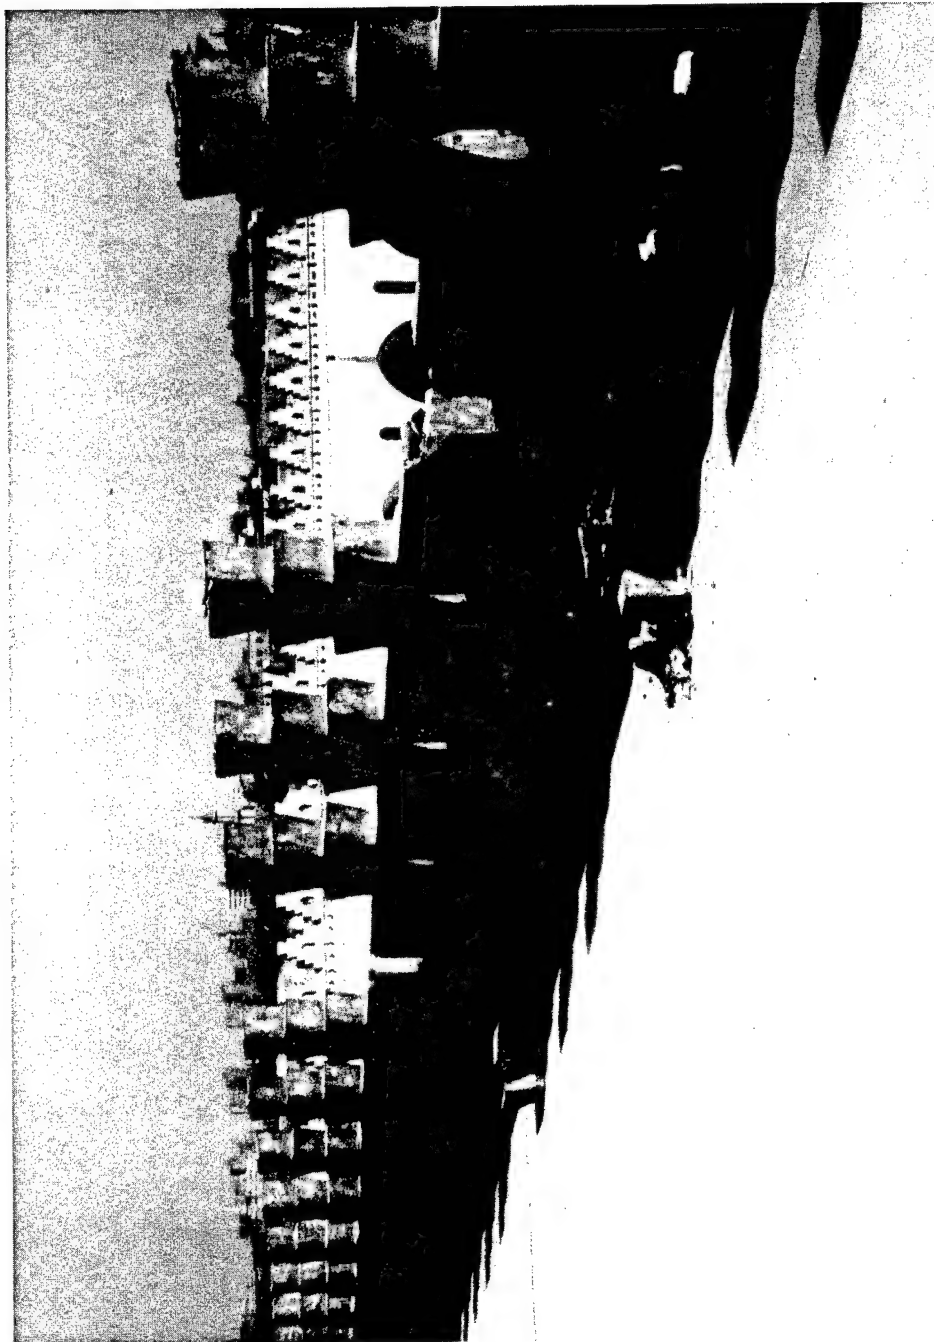
**FIGURE 4-15** Walkway above arcade at al-Hākim Bi-Amrillāh Mosque  
showing fallen parapets

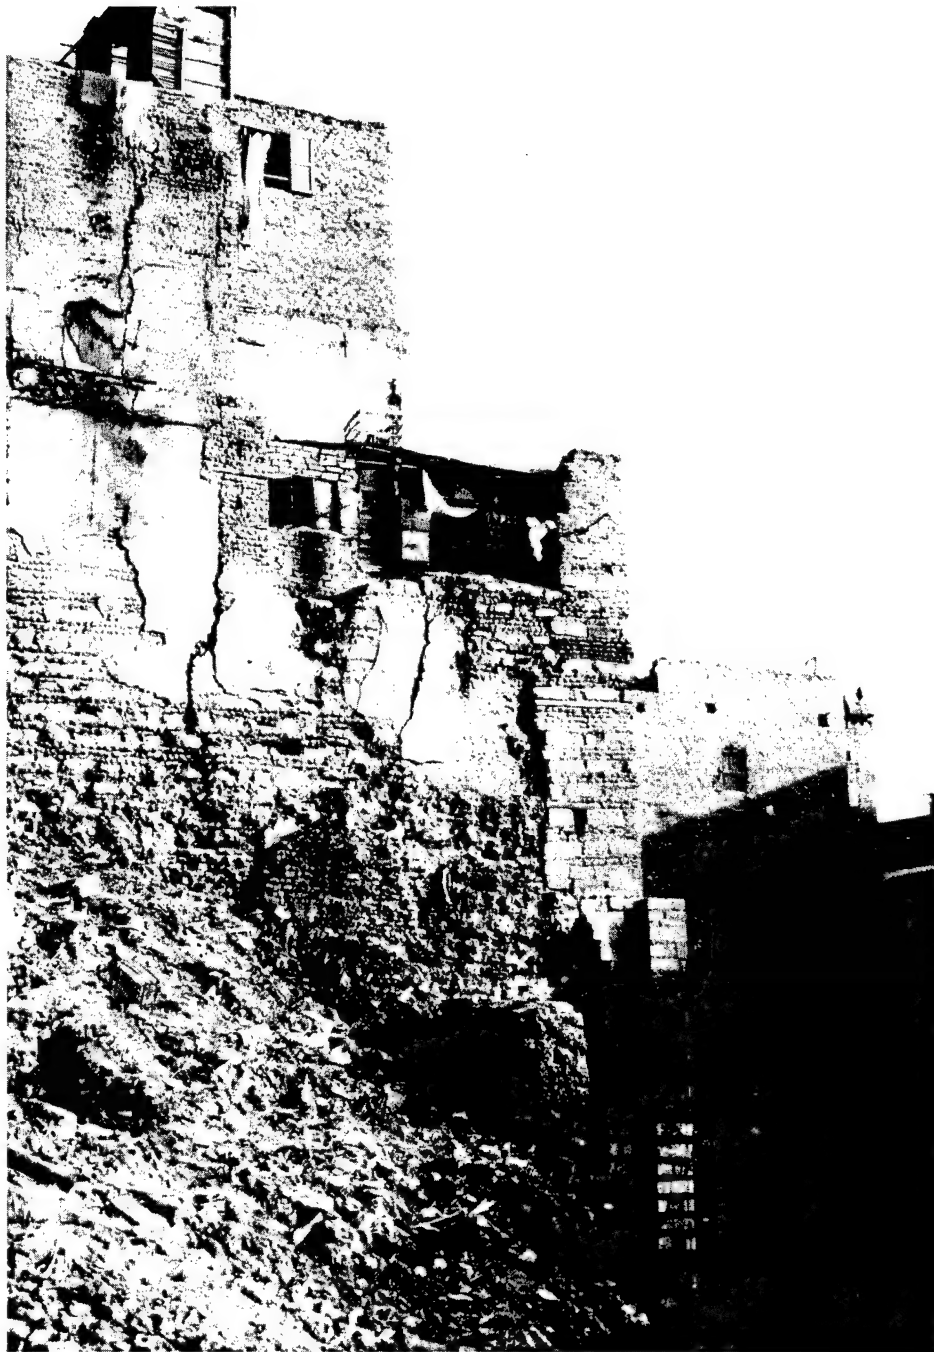
**FIGURE 4-18 Residential housing unit behind remains of Madrasa of as-Sālih Negm ad-Din Ayyub showing significant cracks**

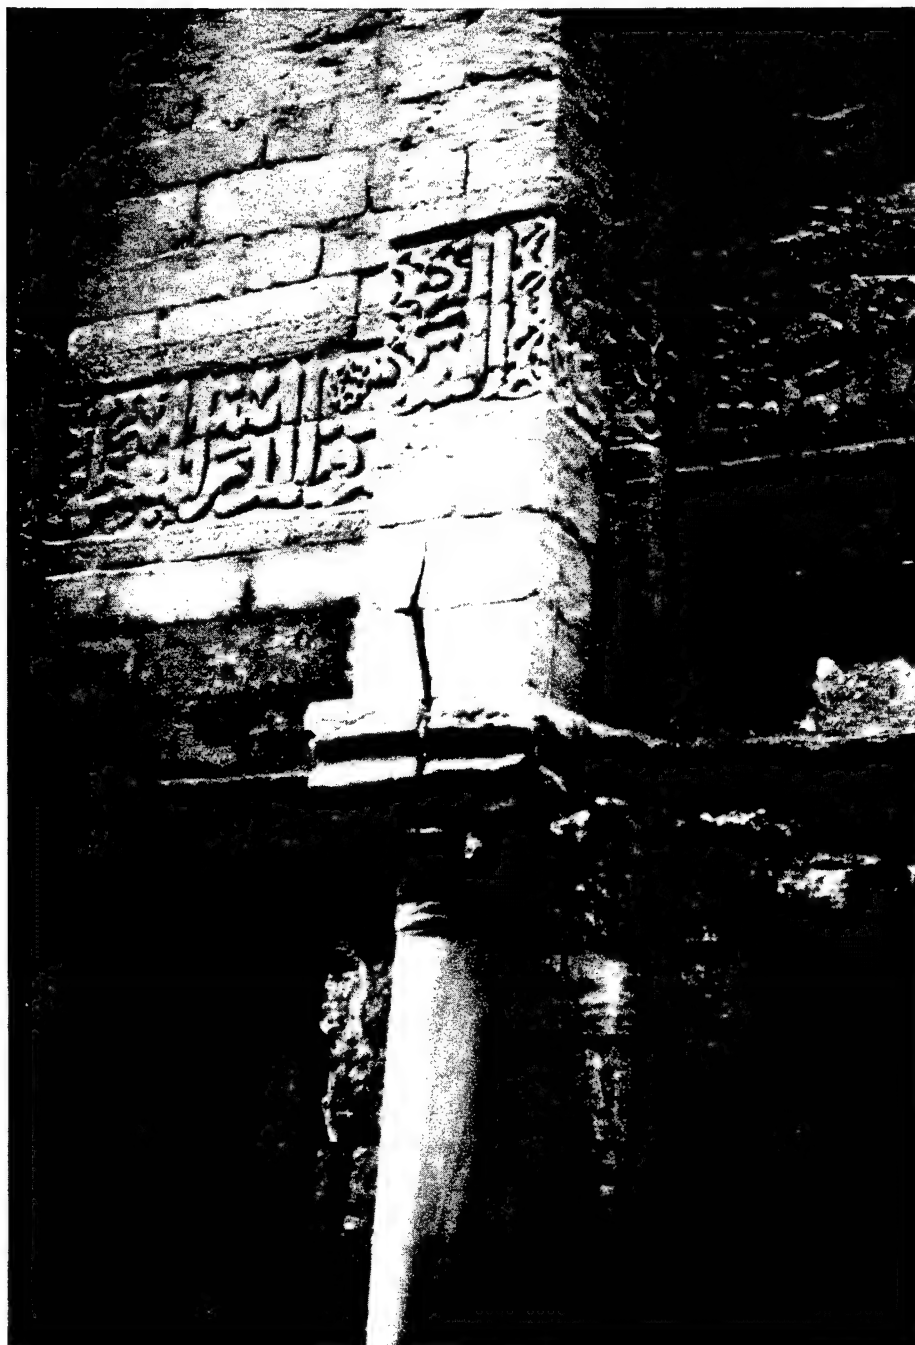
**FIGURE 4-20** Marble column at base of recessed panel at Mausoleum of al-Mansur Qala'un showing large crack

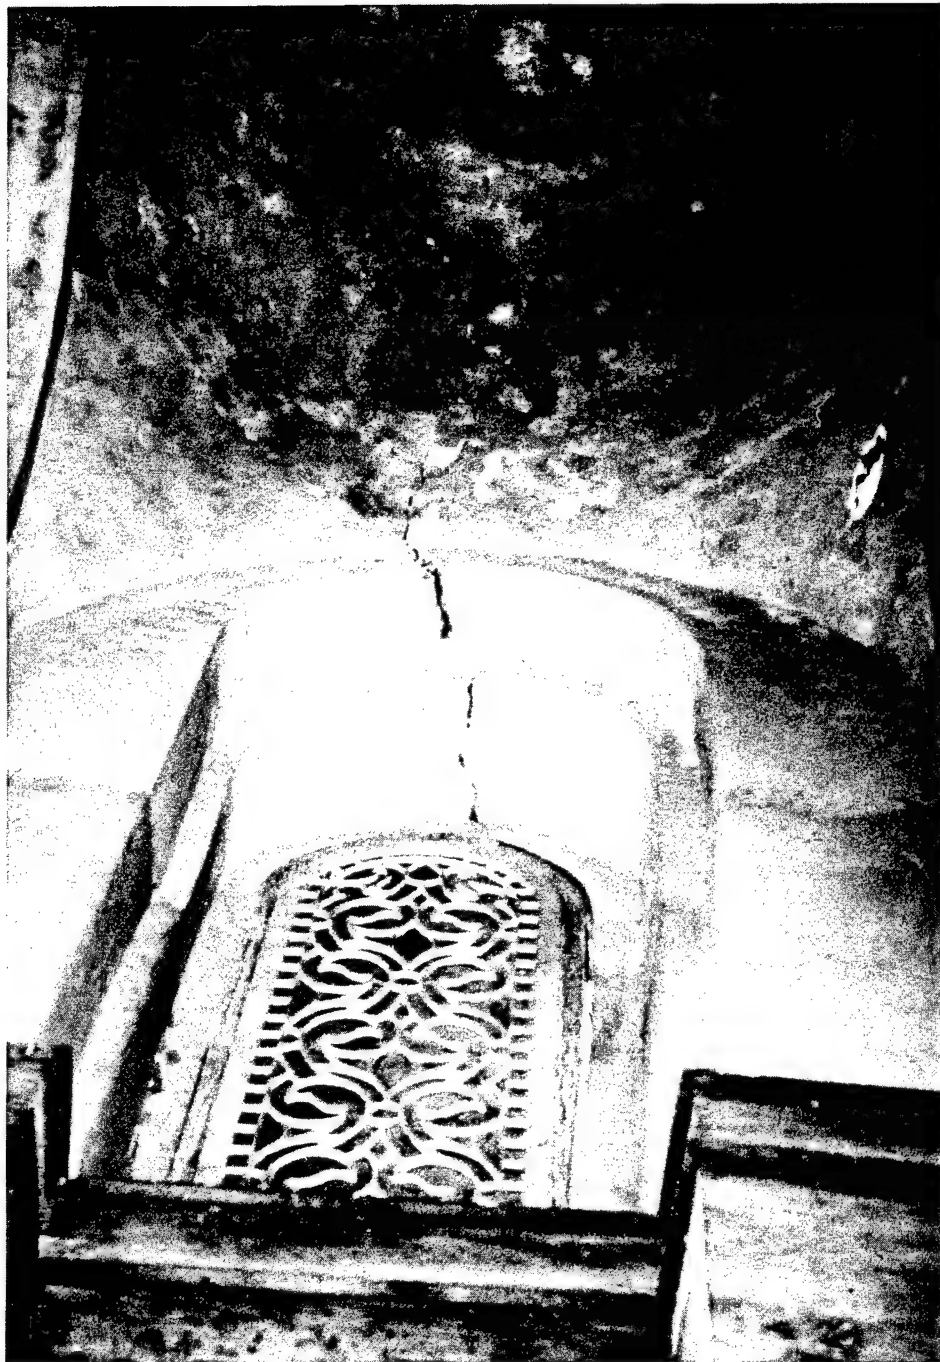
**FIGURE 4-21** Top of arch and minor dome in Mausoleum of al-Mansūr Qala'ūn showing significant cracks

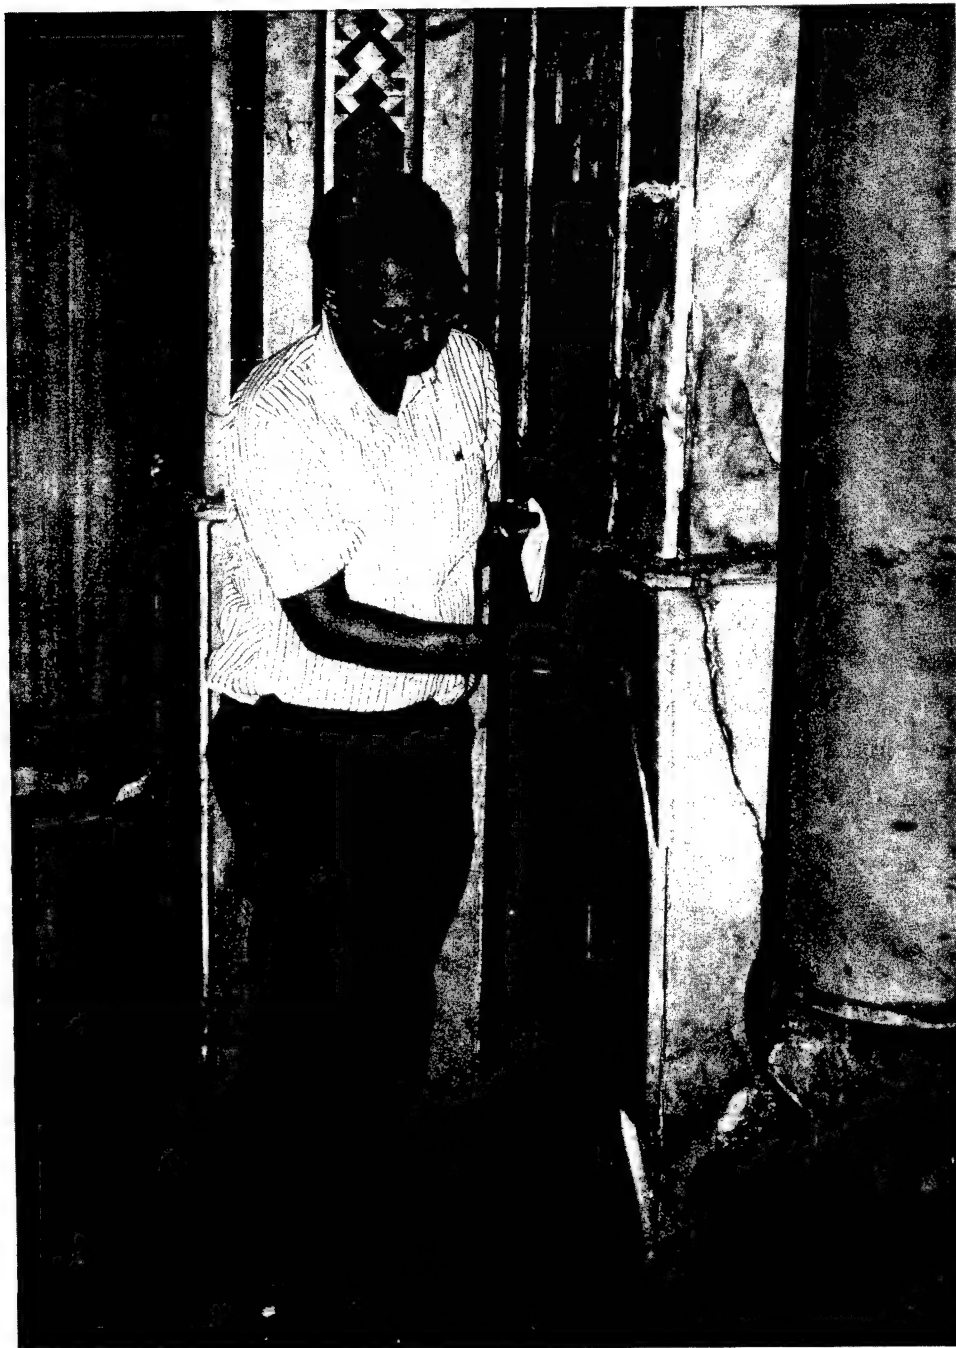
**FIGURE 4-22** Base of pier in Mausoleum of al-Mansūr  
Qala'ūn showing large cracks

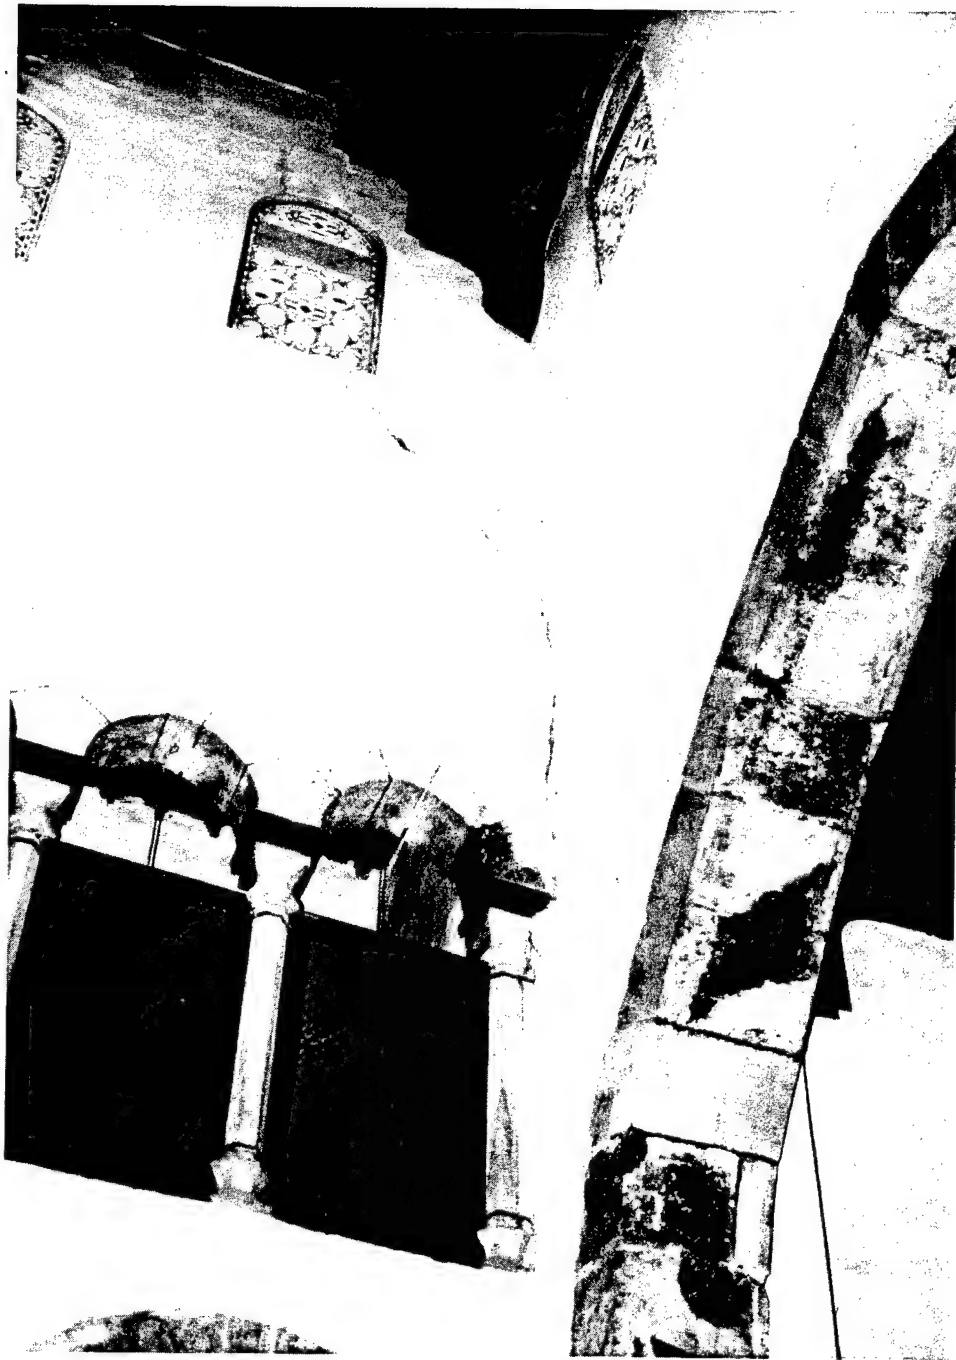
**FIGURE 4-23** Western corner of qa'a at Palace of the Amir  
Beshtak showing large and continuous crack on  
southwest wall emanating from corner

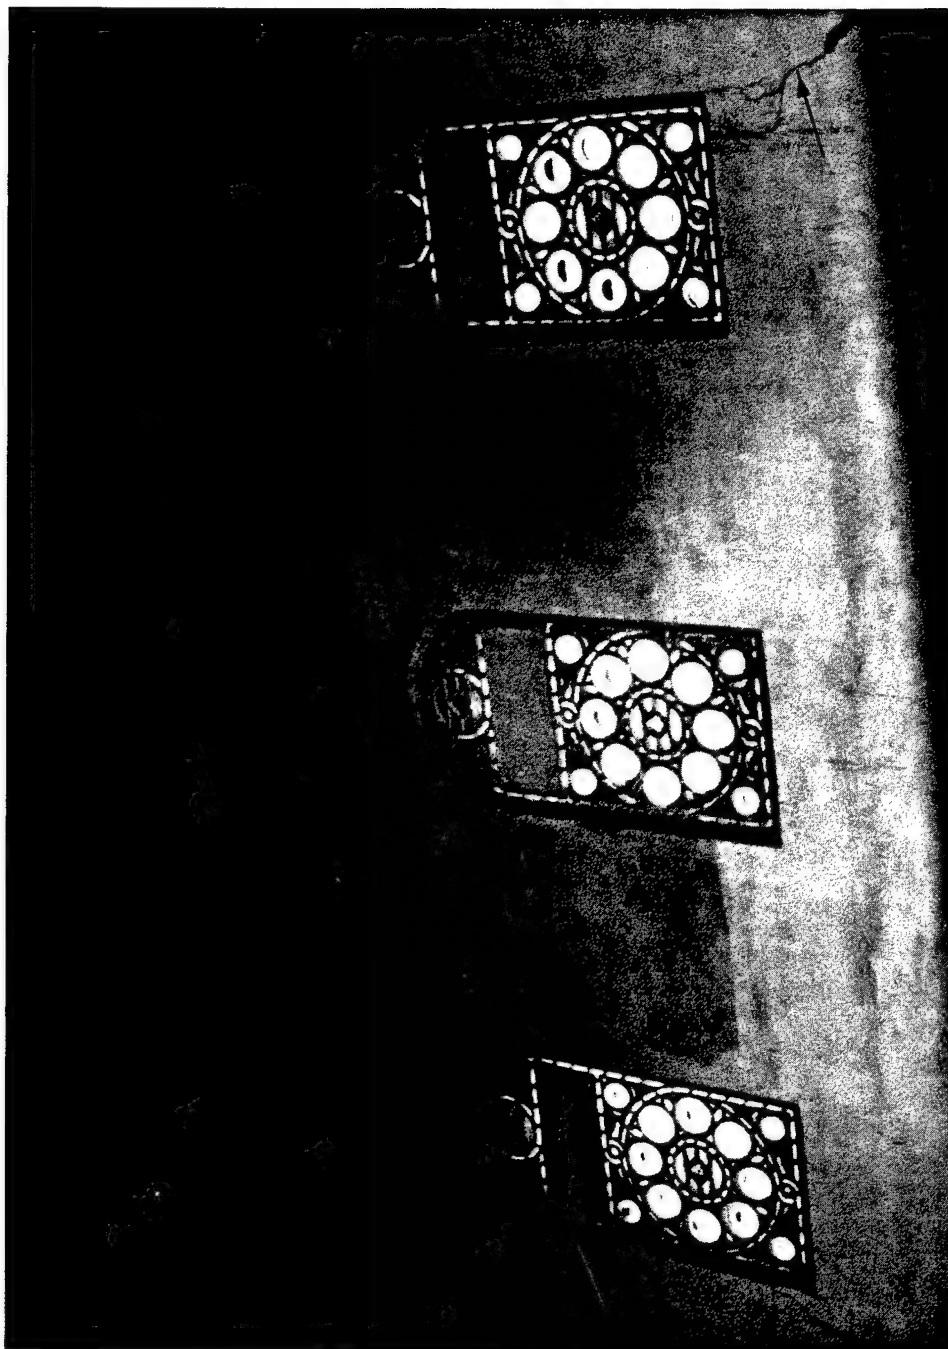
**FIGURE 4-24 Southwest wall of qa'a at Palace of the Amir Beshtak showing extent of large and continuous crack**

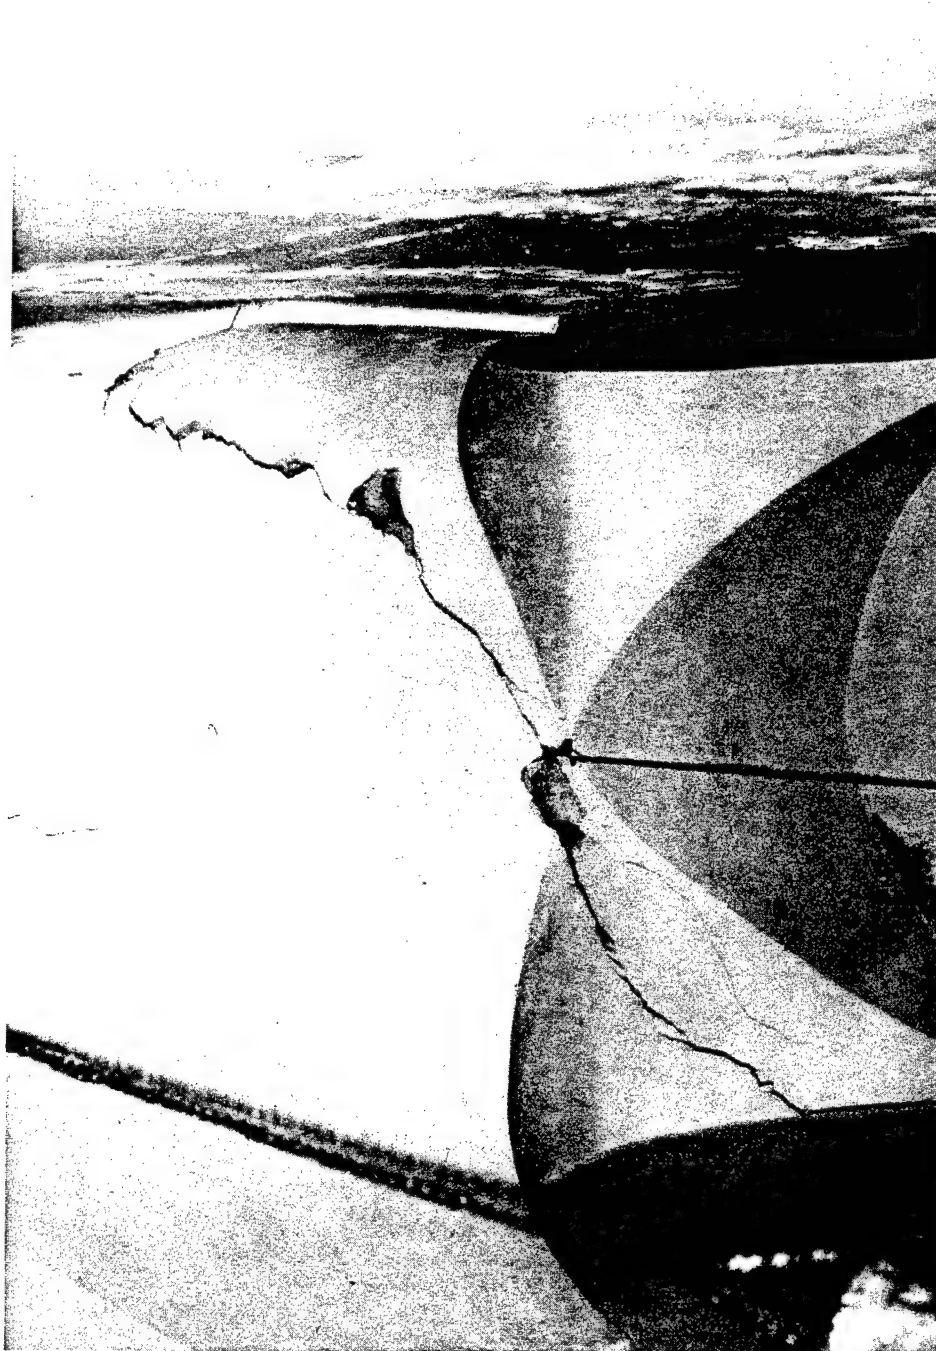
**FIGURE 4-25 Ceiling of hallway on northwest side of Palace of the Amir Beshtāk showing large and extensive cracks**
